## Evaluation of ARINIX® Permethrin Impregnated Nylon Plastic Strips in Preventing Fire Ant Invasion in Electrical Pad-Mount Transformers

Molly Keck, Program Specialist-Urban IPM  
Bastiaan M. Drees, Professor and Extension Entomologist  
Colin Connally, Testing and Standards Specialist, CPS ENERGY

A research project was initiated to determine if ARINIX® strips are a good control option for preventing fire ants from nesting inside and invading pad mount electrical transformers.

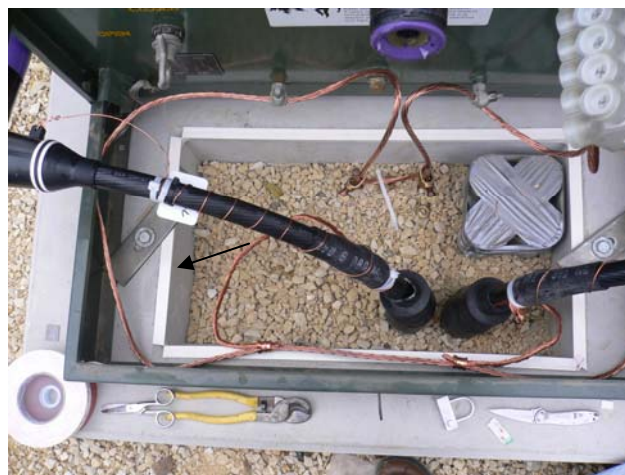
**Figure 1.** Pad mounted electrical transformer box containing ARINIX permethrin impregnated nylon plastic strips.

Transformers were randomly assigned to one of two treatment groups: untreated controls and treated transformers. L-shaped ARINIX® strips of 60 inches long were installed in 35 transformers along the inner edge of the concrete pad the transformers sit upon. Strips were cut to fit within the transformers and held in place by a bolt already within the boxes (**Fig. 1**). All installation was performed by CPS ENERGY personnel.
